**CONSENT ORDER
ISSUED UNDER THE
WATER POLLUTION CONTROL ACT
WEST VIRGINIA CODE, CHAPTER 22, ARTICLE 11**

TO: Mountain Valley Pipeline, LLC
Attn: Robert J. Cooper
Senior Vice President, Engineering and Construction
625 Liberty Ave, Ste 1700
Pittsburgh, PA 15222

DATE: April 19, 2019

ORDER NO.: 8951

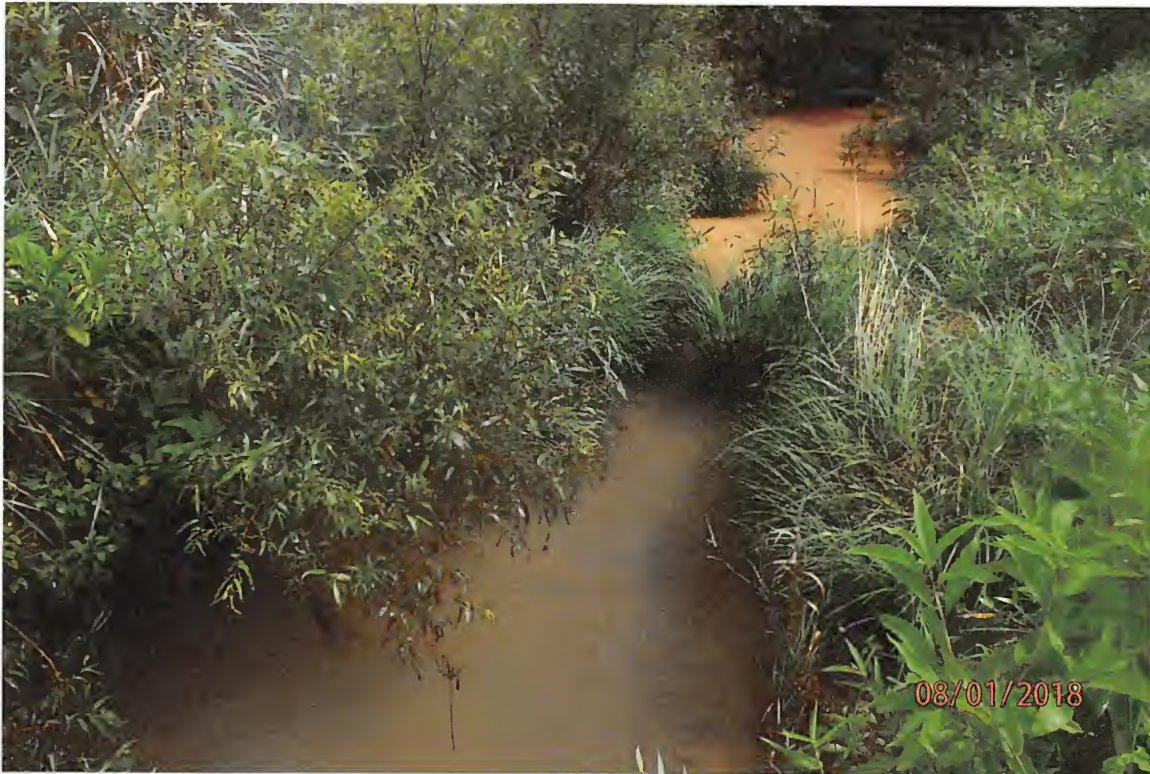
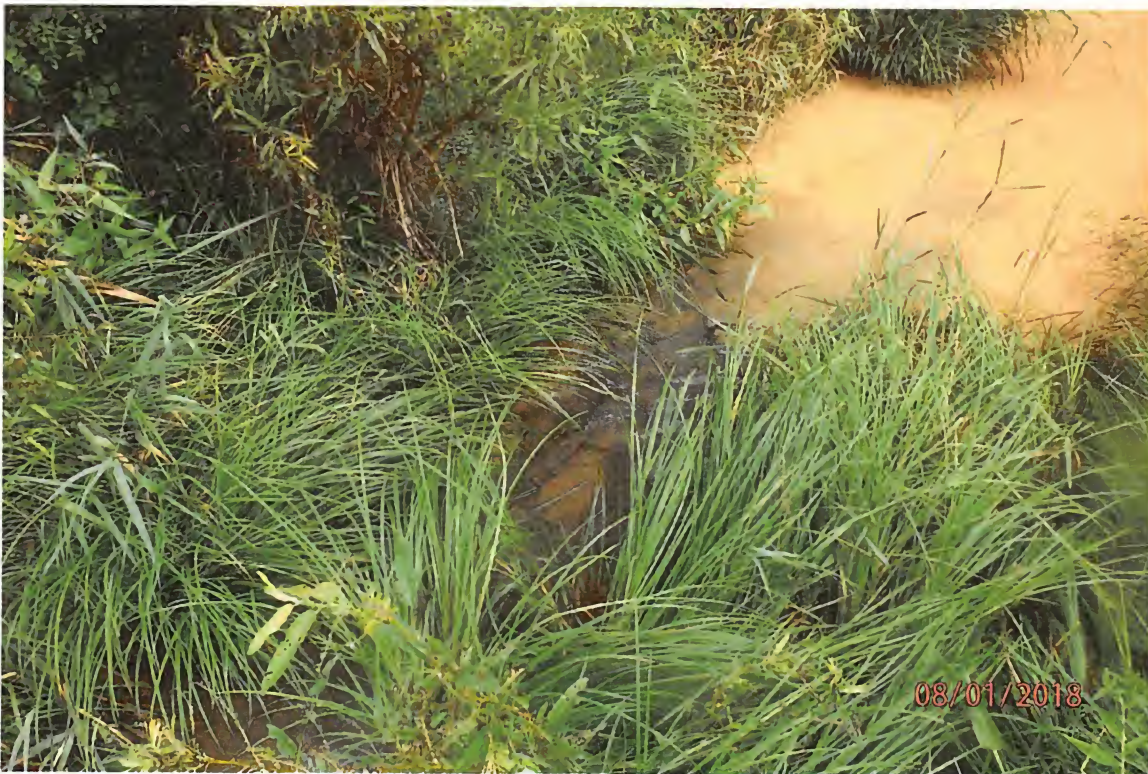
Improperly operated BMP that is causing sediment laden water to leave the site and CNA visible in Big Elk Creek.

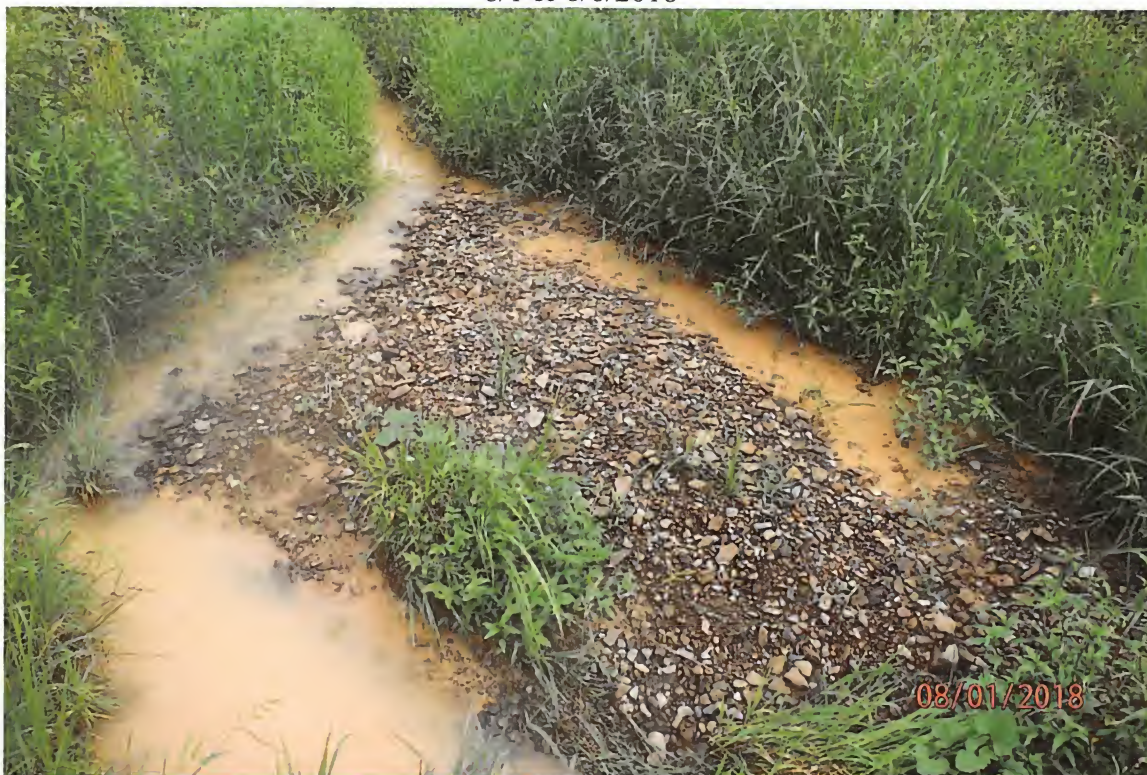
Perimeter control that has been overwhelmed due to concentrated flow from improperly installed water bars in the Goose Run watershed.

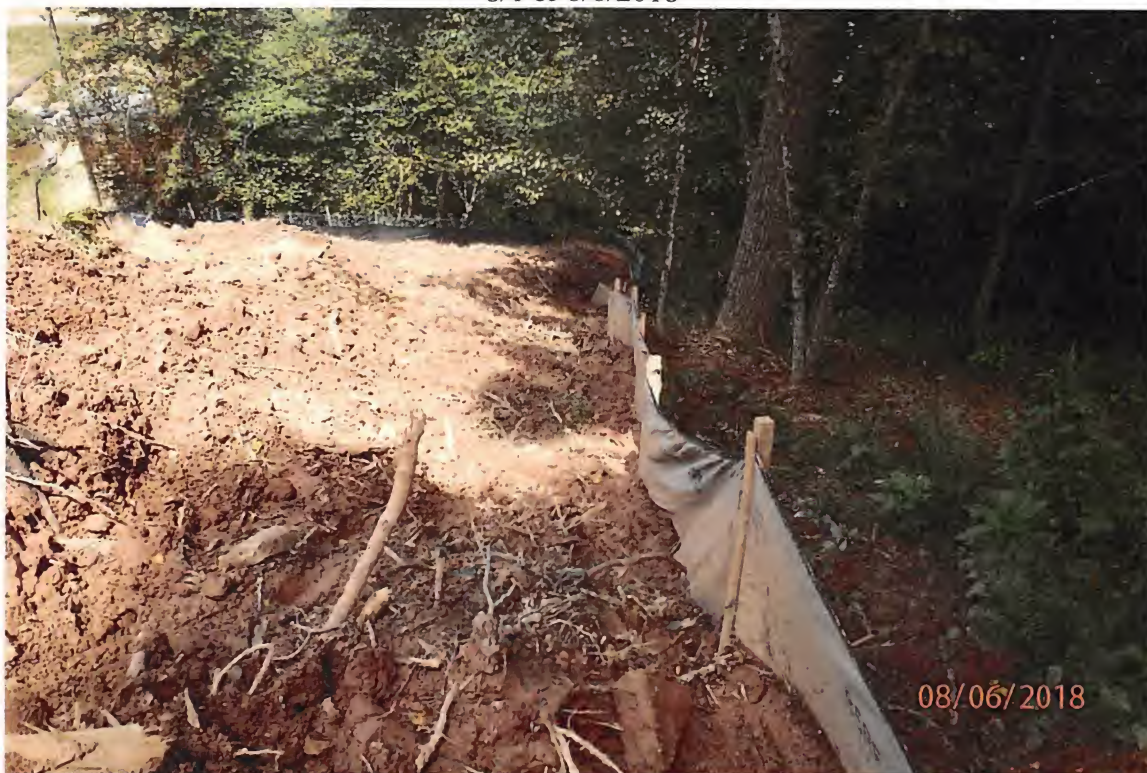
Water bar in Grass Run watershed that is improperly installed and led to CNA deposits in the stream.

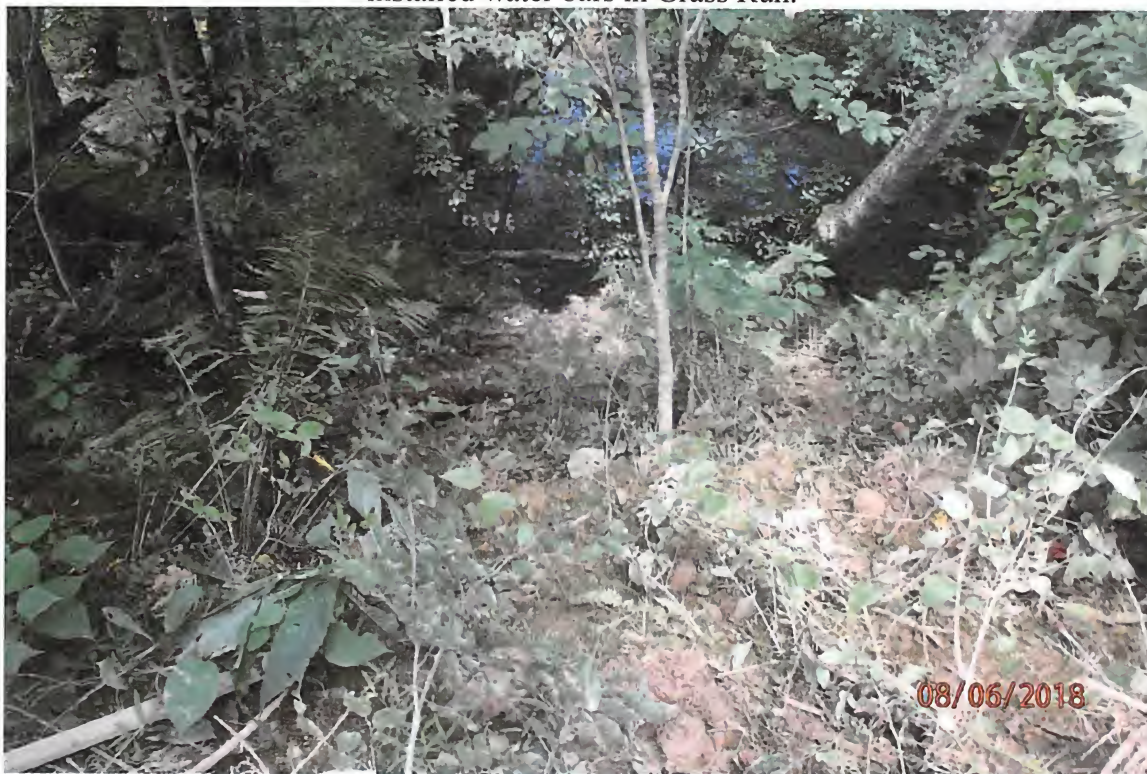
Concentrated flow being directed over fill slope into a sheet flow super silt fence from improperly installed water bars in Grass Run.

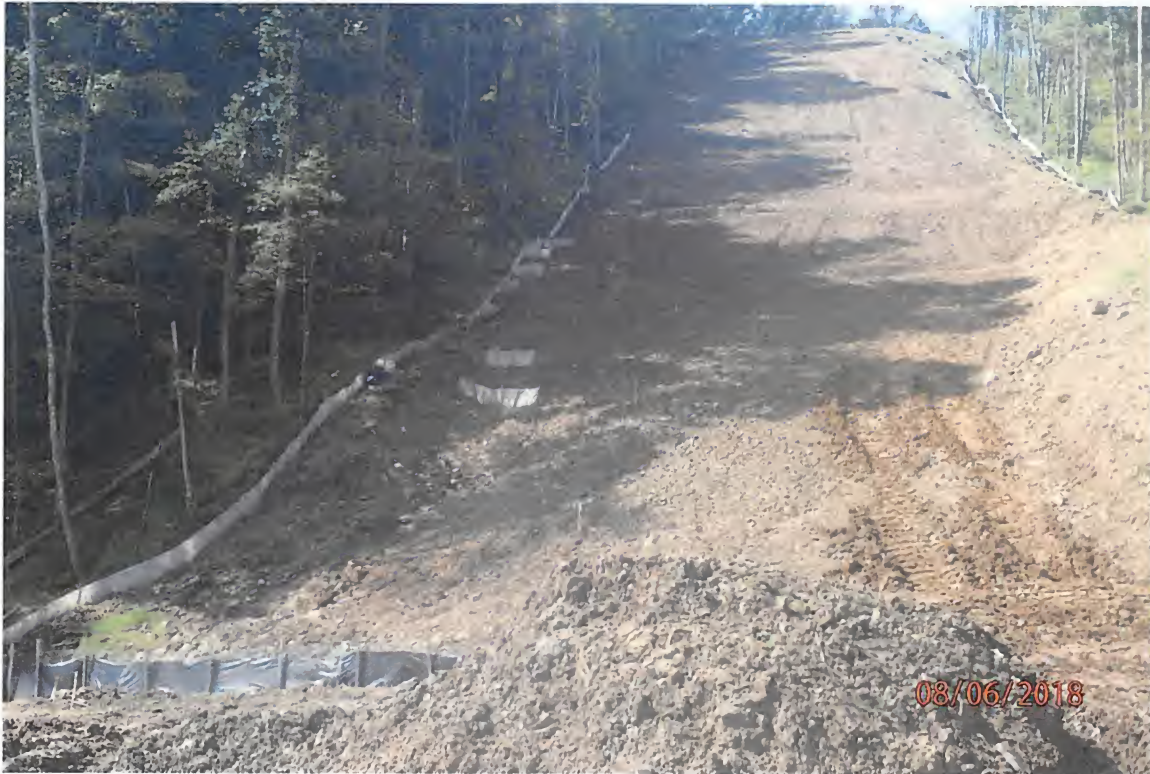
Offsite CNA deposits in Grass Run (39° 20.1127' X 80° 31.3233') that originate from site.

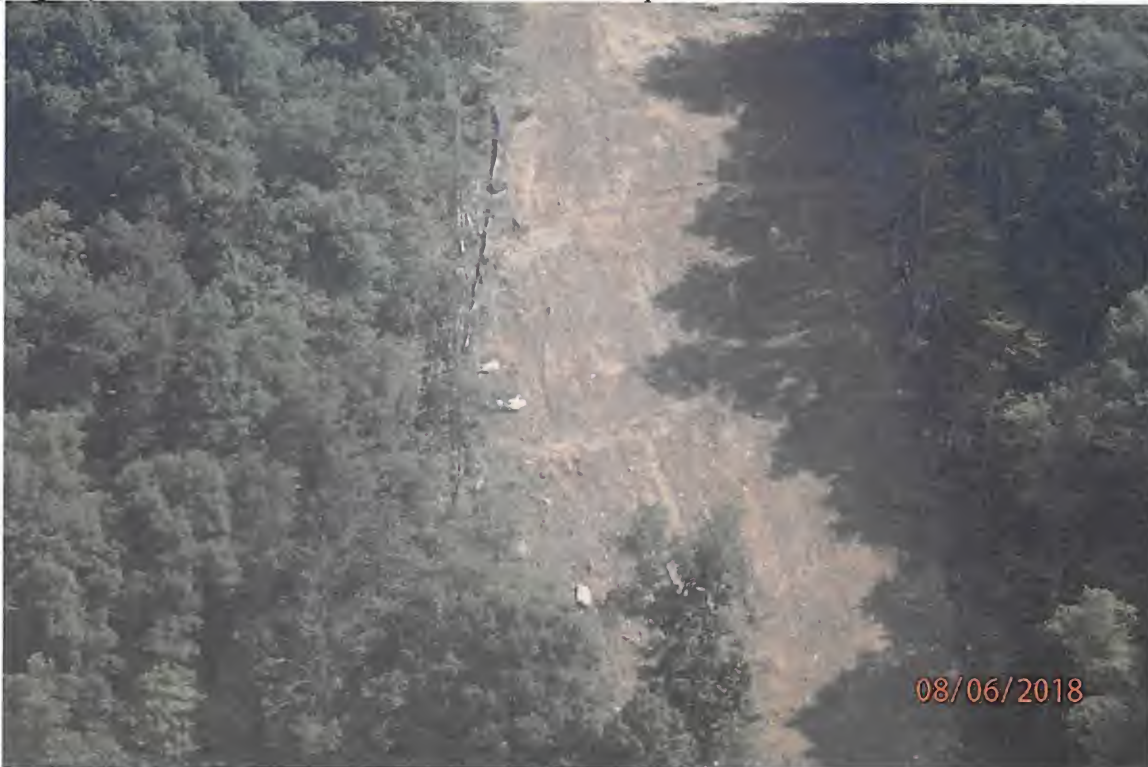
Improperly installed water bars and associated fill slope erosion in the Tenmile Creek watershed.

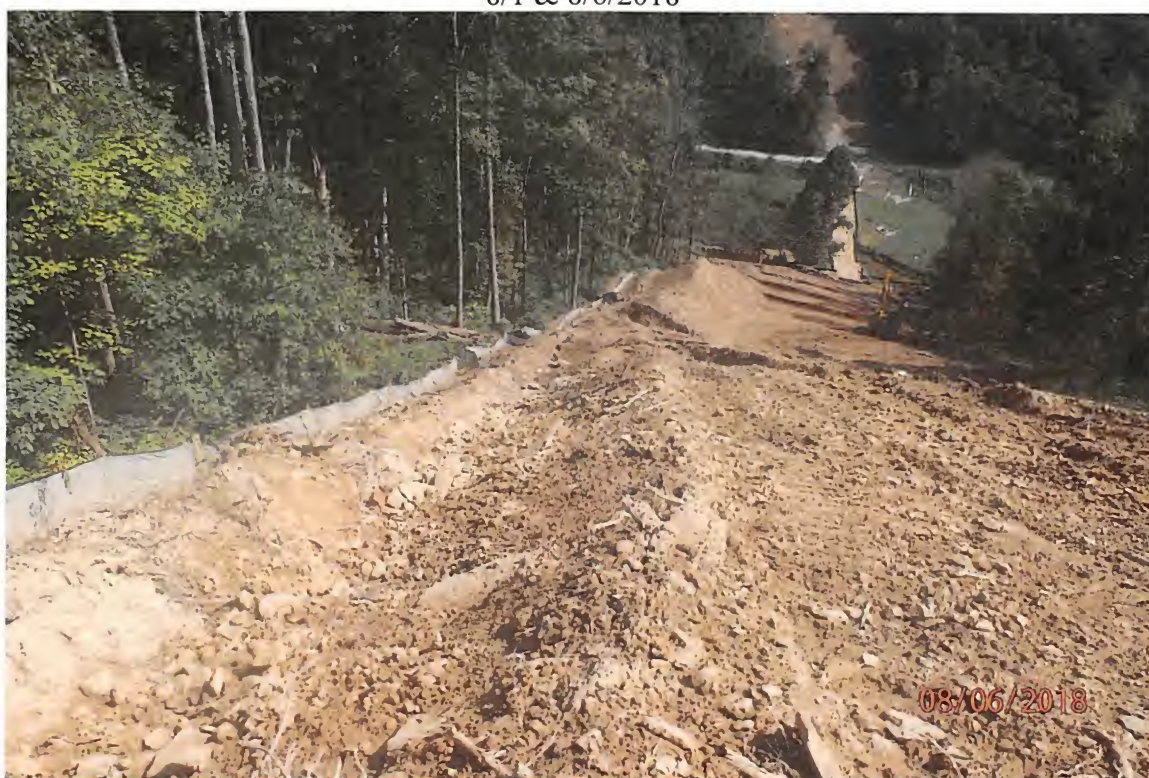
Improperly installed water bars and associated fill slope erosion in the Little Rockcamp Run watershed.

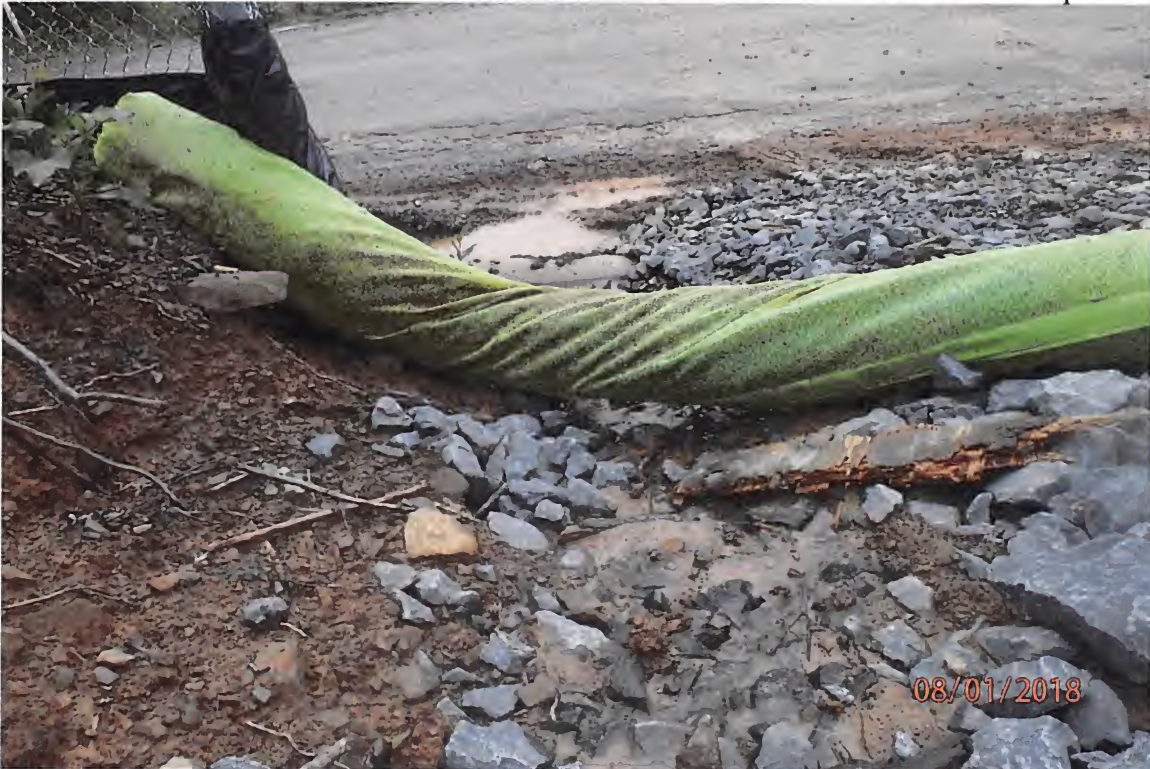
BMP in Seal Run watershed in need of maintenance that led to offsite sediment deposits.

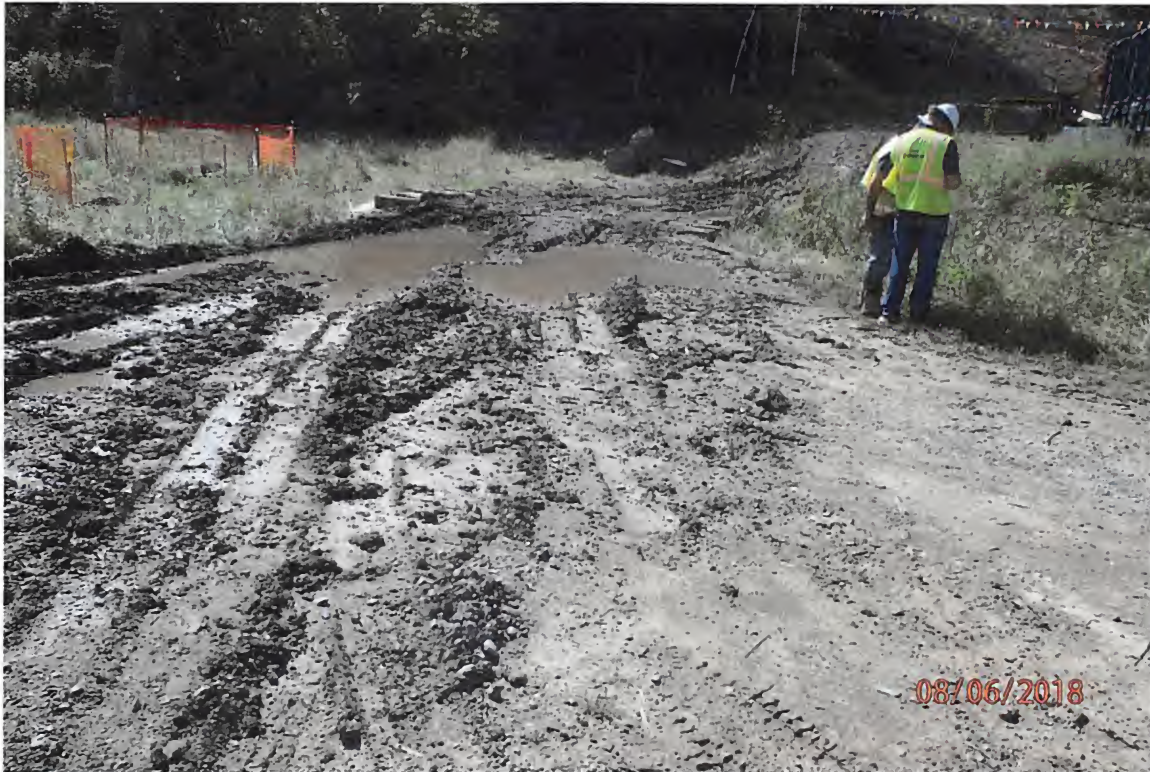
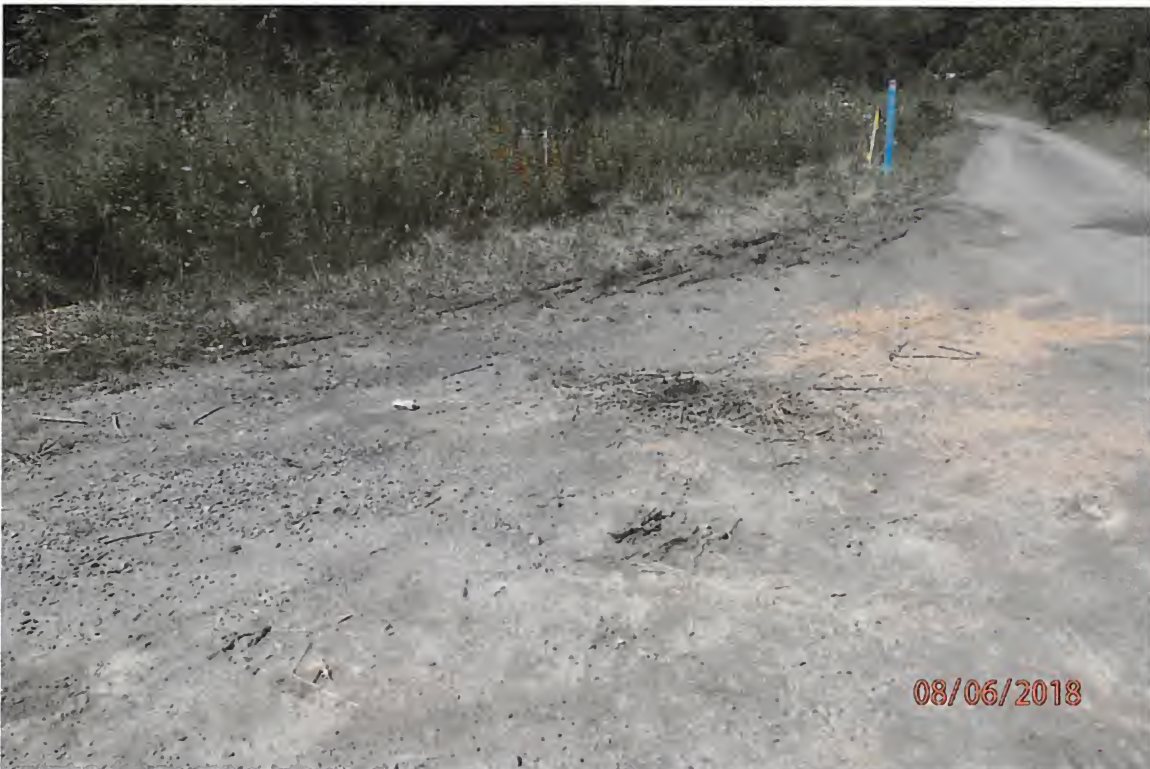
Improperly operated BMP in Right Fork of Big Elk watershed.

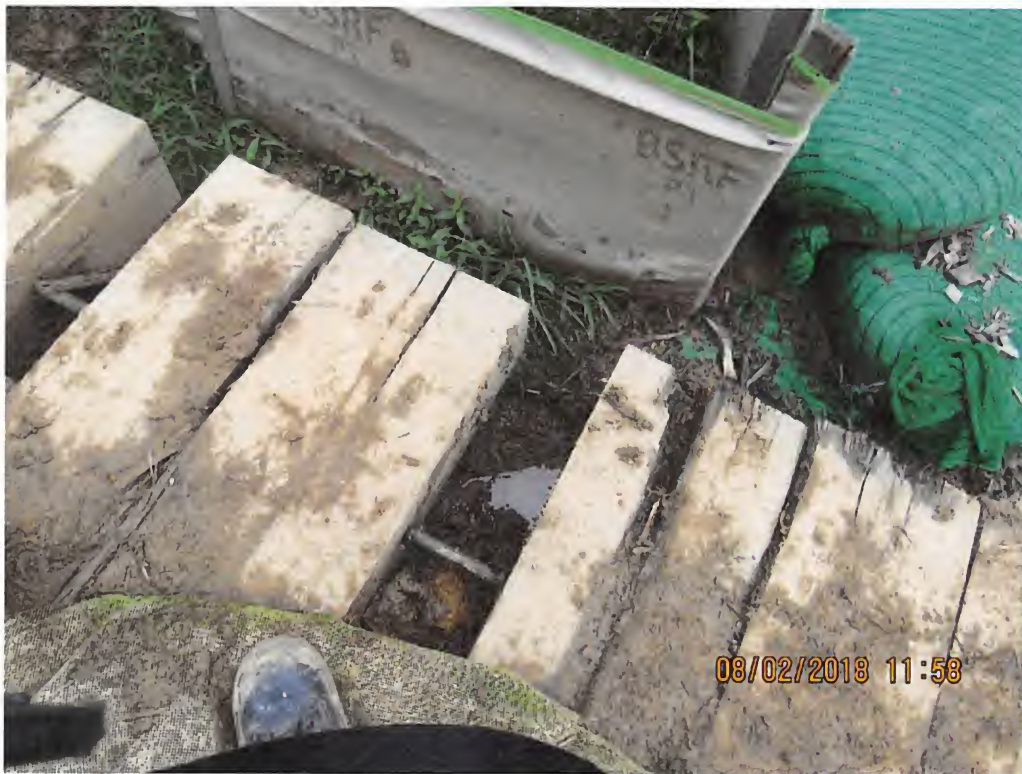
Sediment deposits observed below base of Slate Run bridge.

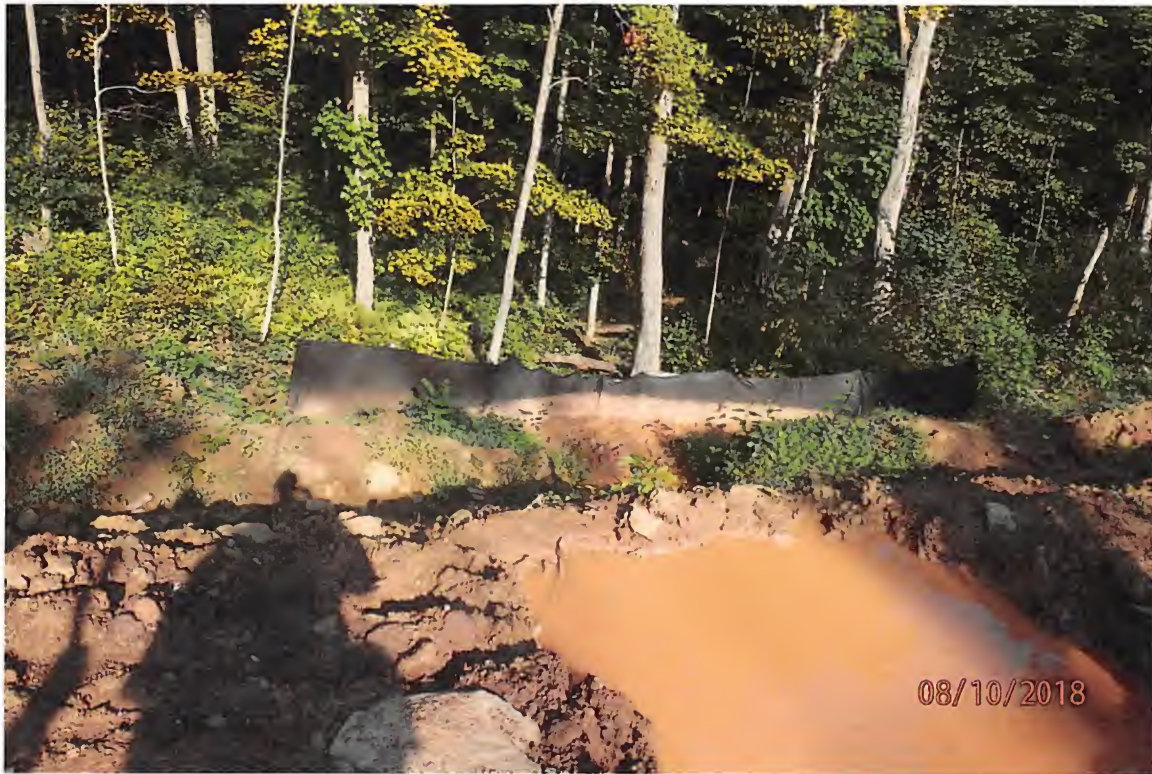
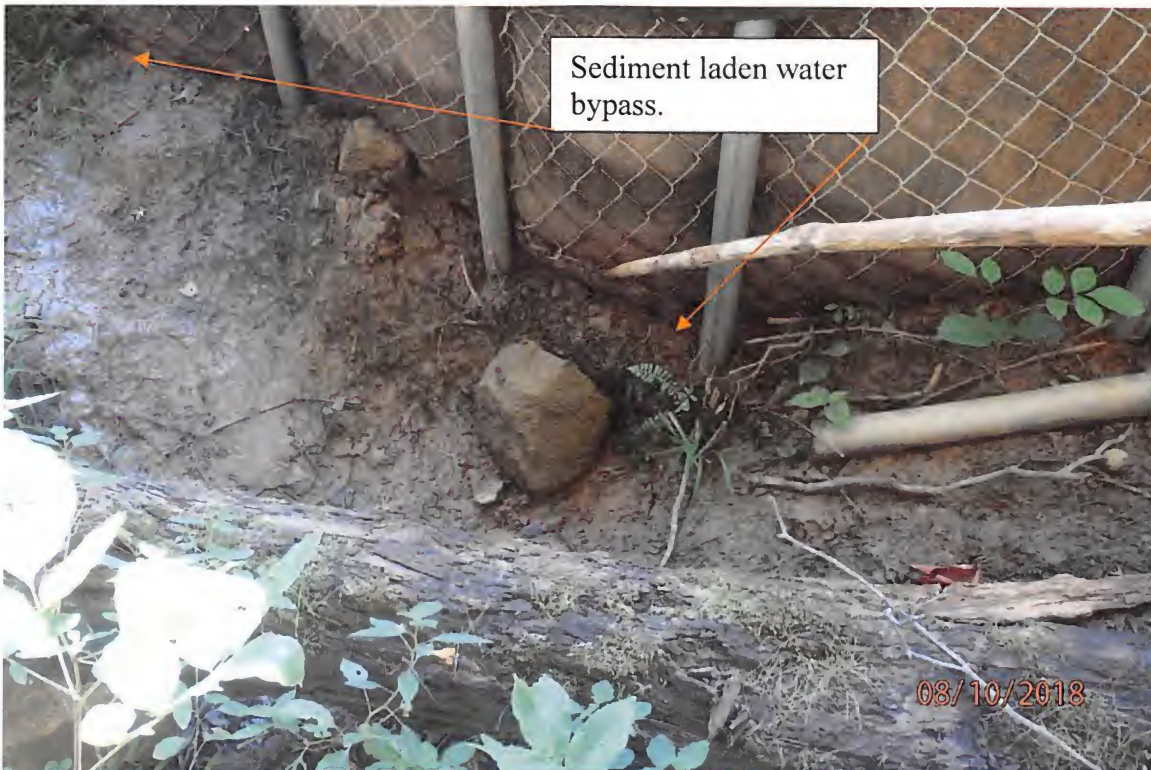
Culvert outlet into wetland area across road from full sump.

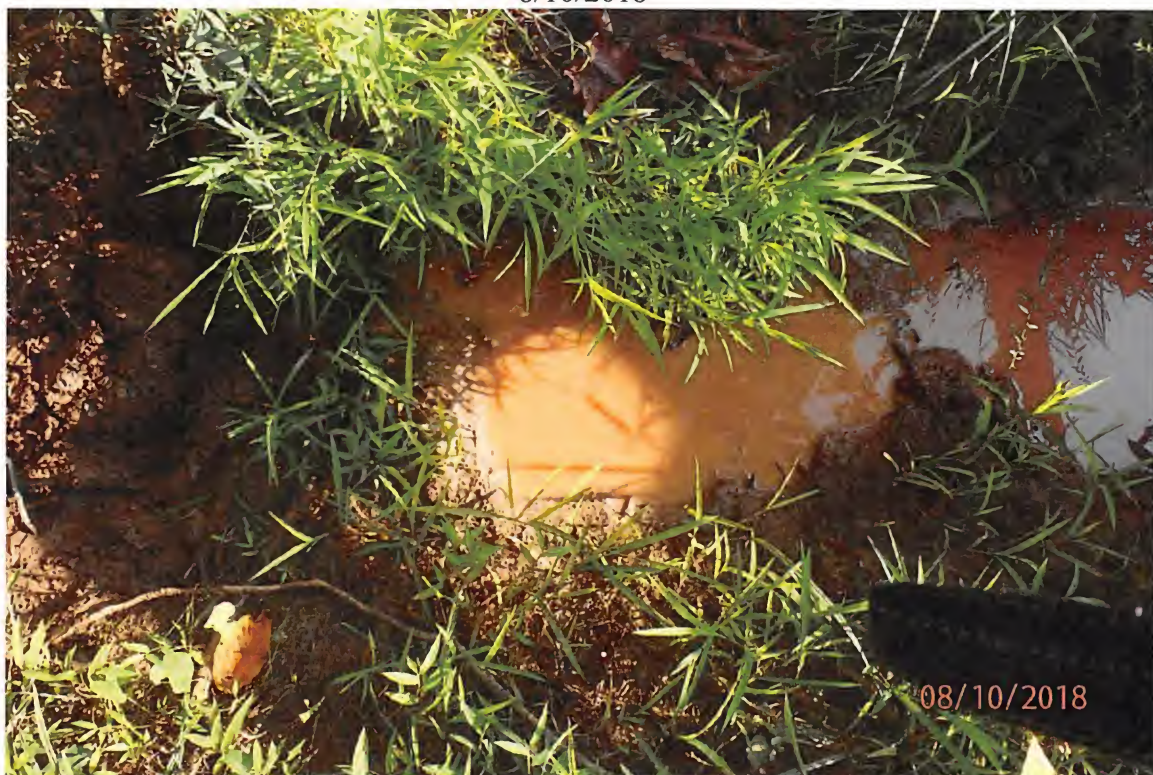
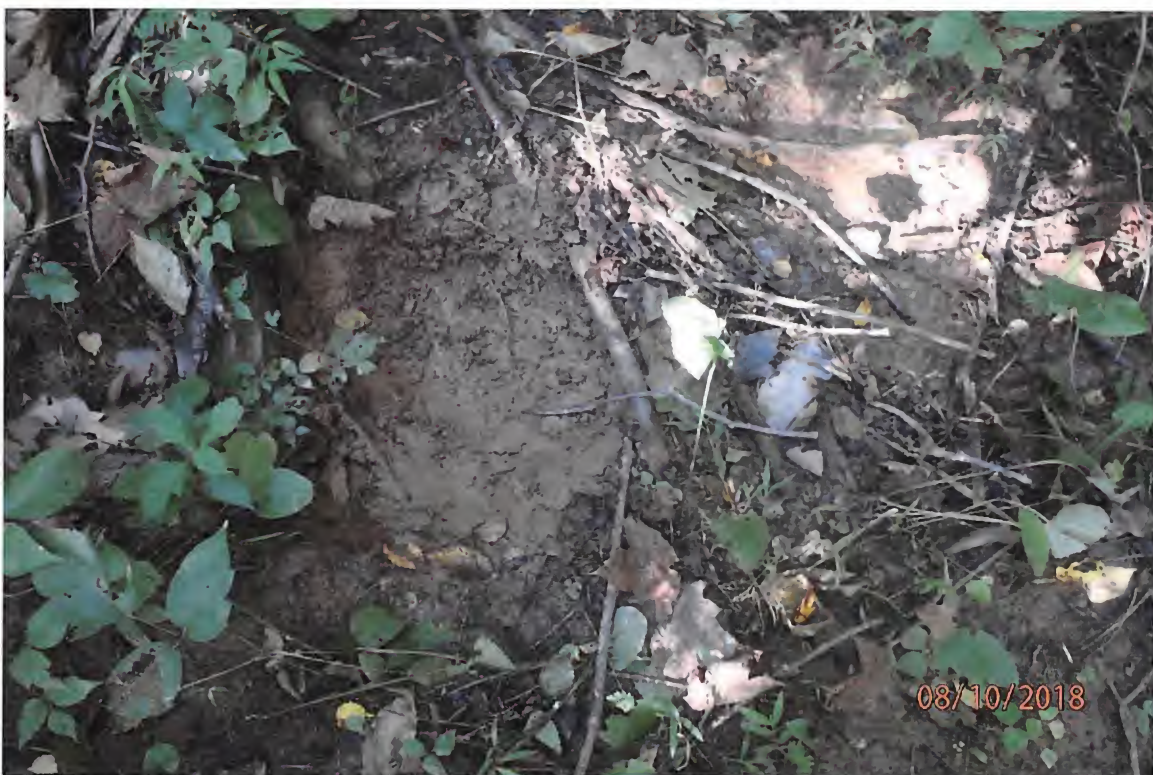
Improperly operated and maintained BMP at a water bar terminus in the Meathouse Fork watershed that led to CNA deposits and distinctly visible settleable solids in UNT Meathouse Fork (39° 11.891' X 80° 33.209').

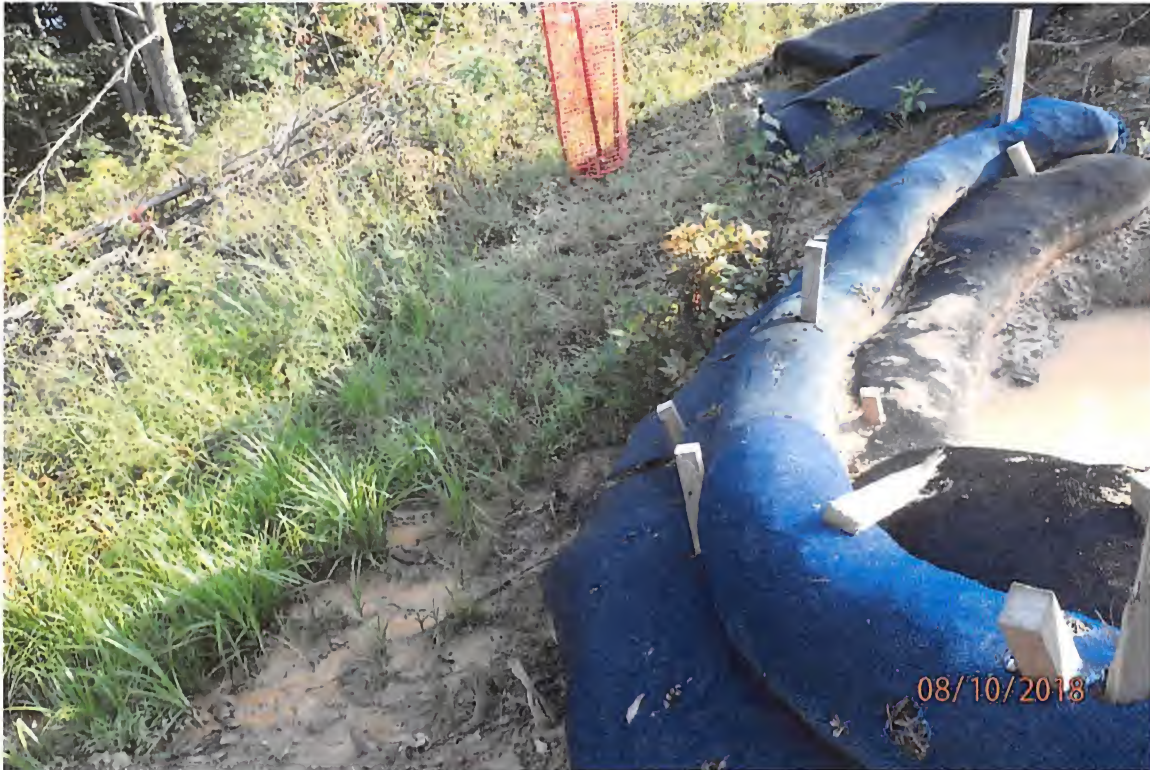
CNA deposits and distinctly visible settleable solids in UNT Meathouse Fork (39° 11.891' X 80° 33.209')
that originate from site because of the previously pictured deficiencies.

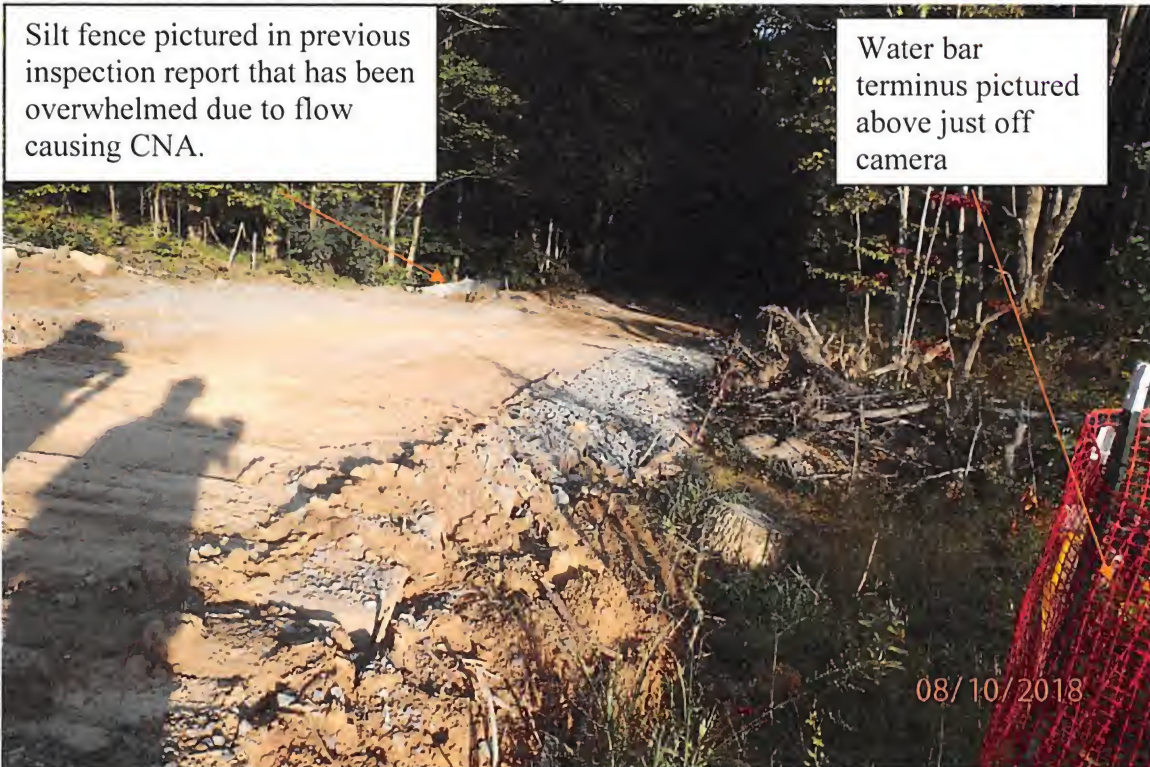
Water bar terminus that discharges onto MVP-DO-049 access road.

Silt fence pictured in previous inspection report that has been overwhelmed due to flow causing CNA.

Water bar terminus pictured above just off camera

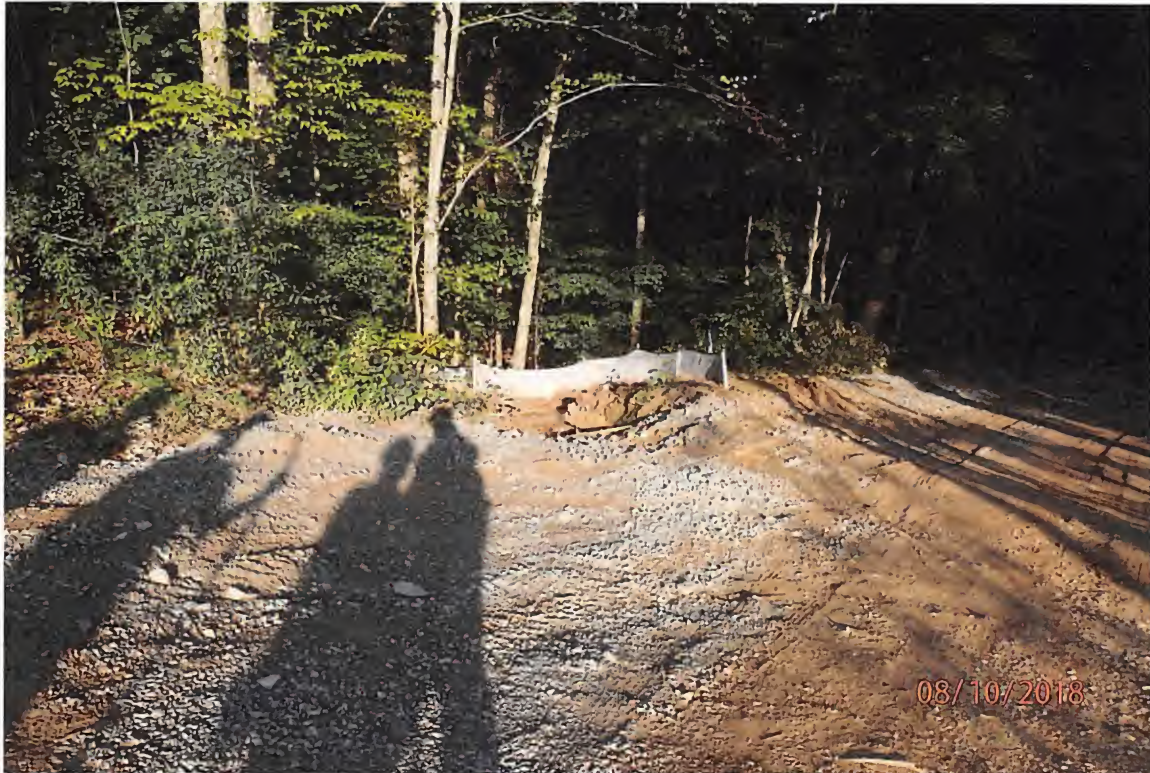
Overview of drainage area leading to BMP that is continuously overwhelmed due to the amount of flow at access road MVP-DO-049. Recent CNA deposits in UNT Dry Fork (39° 11.377' X 80° 33.566') were noted as a result.

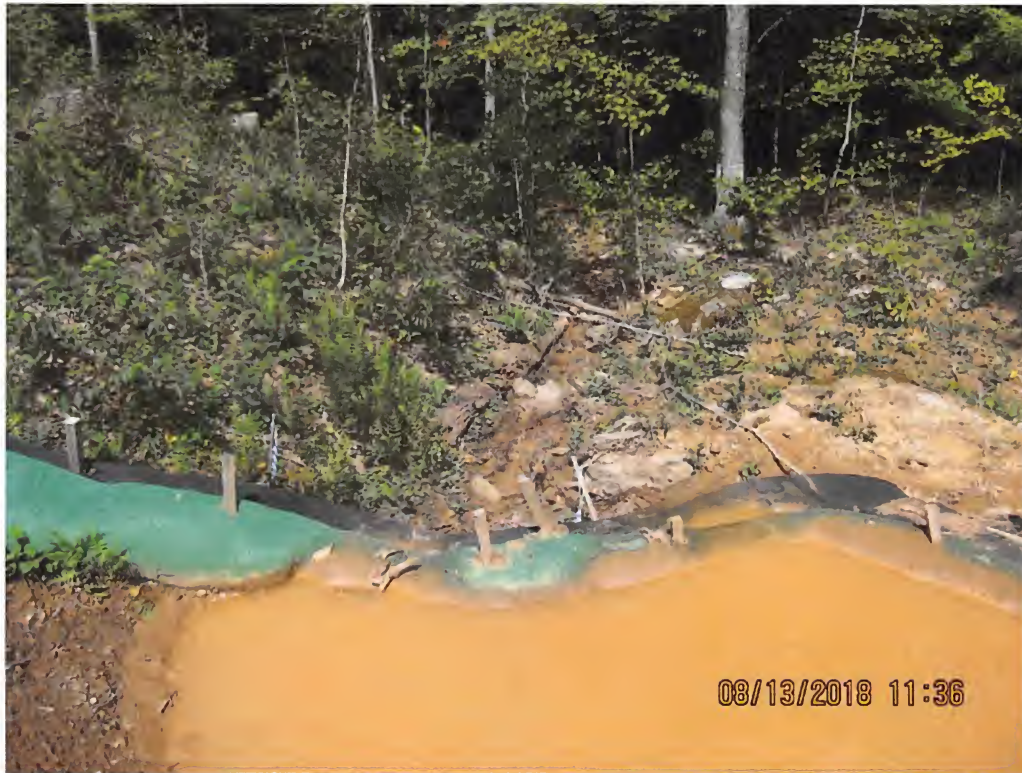
At St. 00+220 a series of perimeter controls used in a concentrated flow area had failed allowing sediment laden water to leave the site. Sediment deposits were noted in receiving stream A-104 creating Conditions Not Allowable in the Waters of the State.

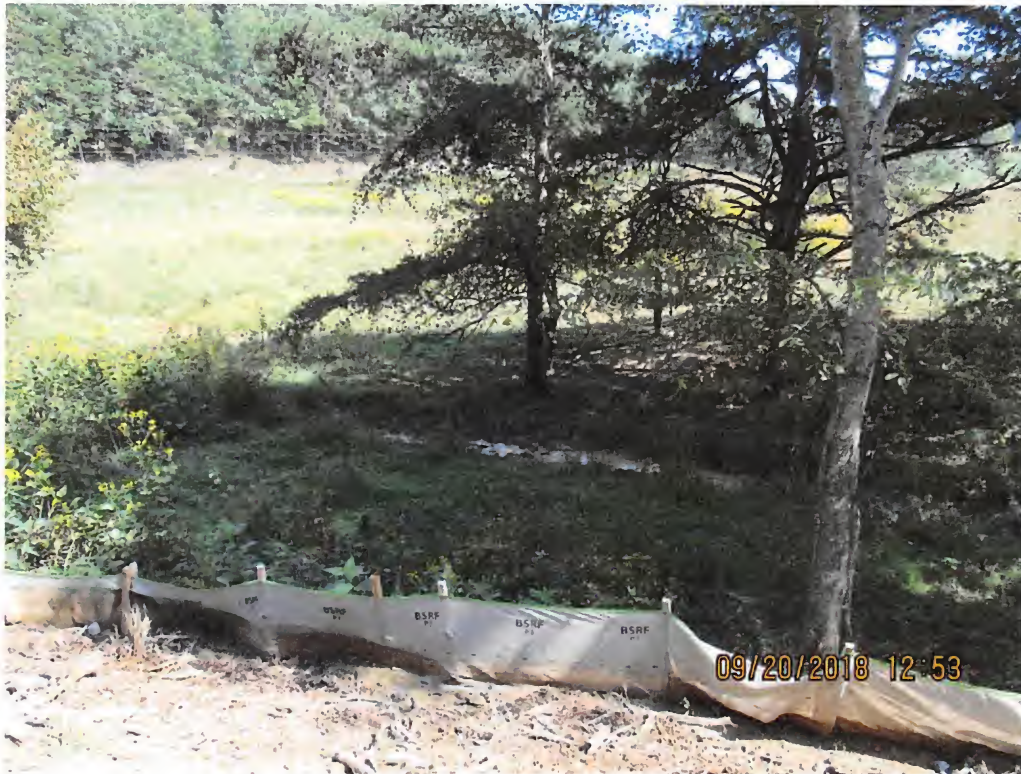
Photo 2: Silt fence needs replaced along access road 231.01 off Painters Run Road near station 10270+49.

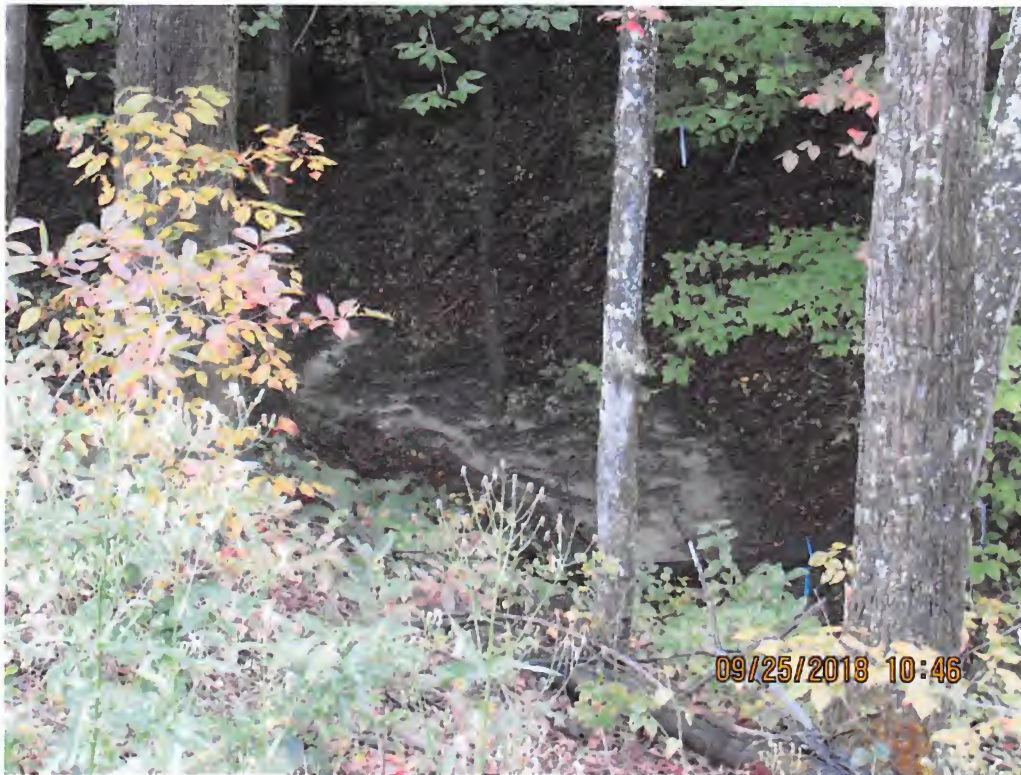
Photo 2: Station 550 sump at base of fill slope where perimeter controls failed and sediment laden water leaving site.

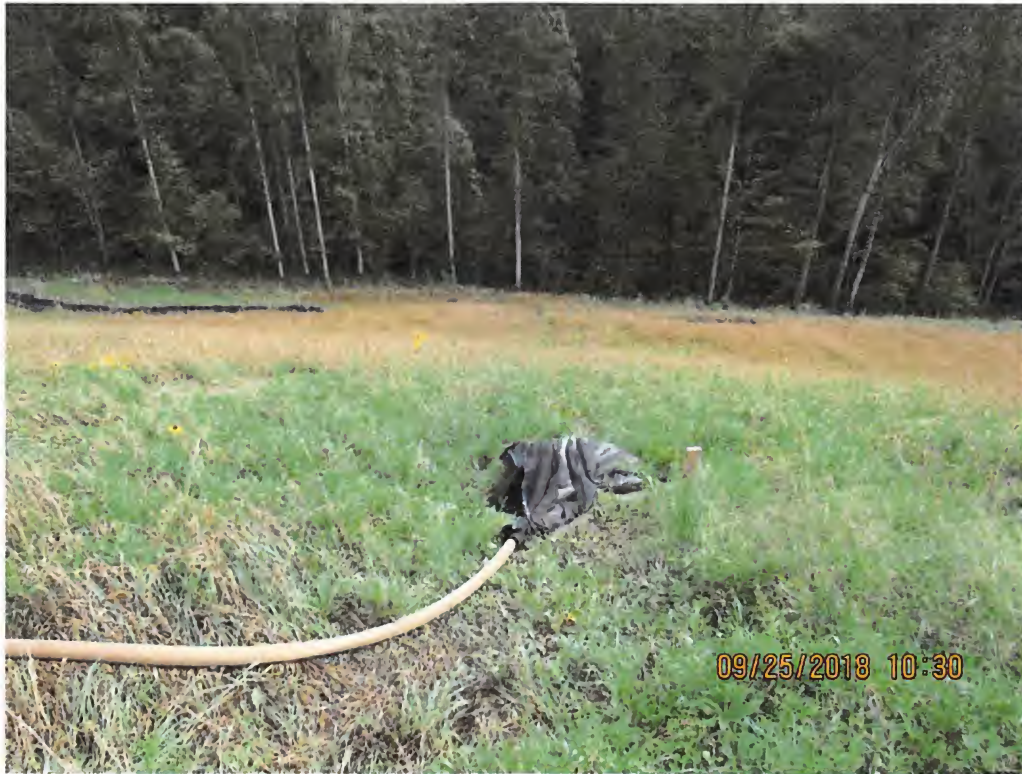
Photo 4: 1 of 3 improperly installed filter fabric bags still in use on north eastern side of site.

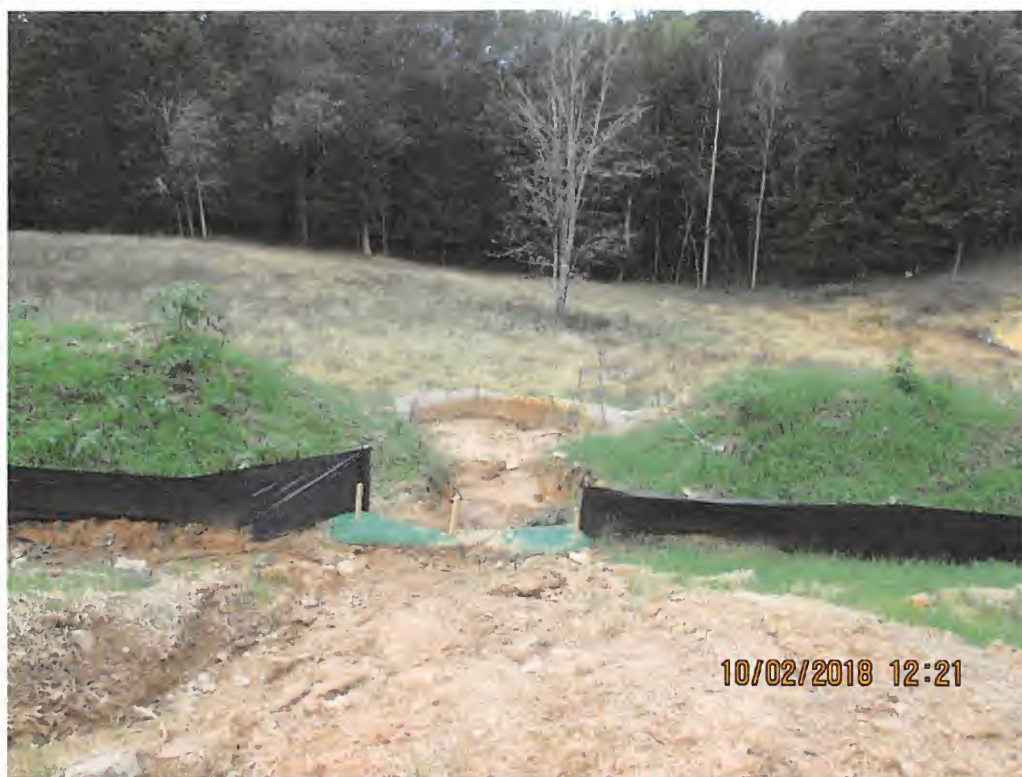
ROW near station #9687 where multiple BMP's are failing.

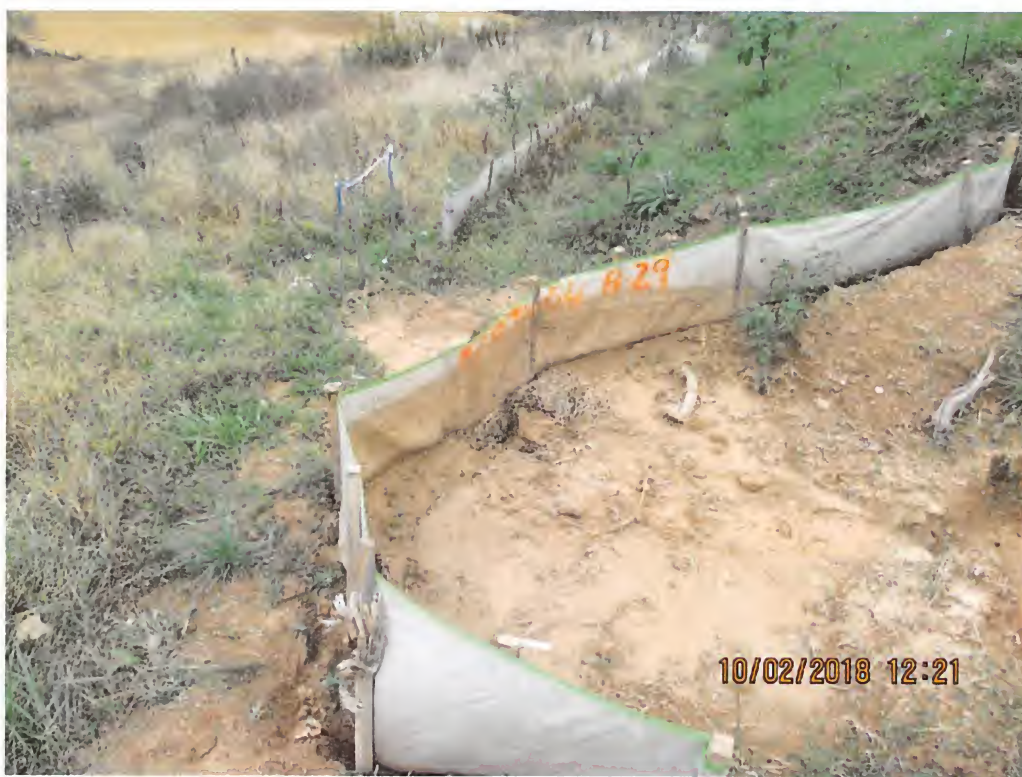
ROW near station #9687 where BMP is failing.

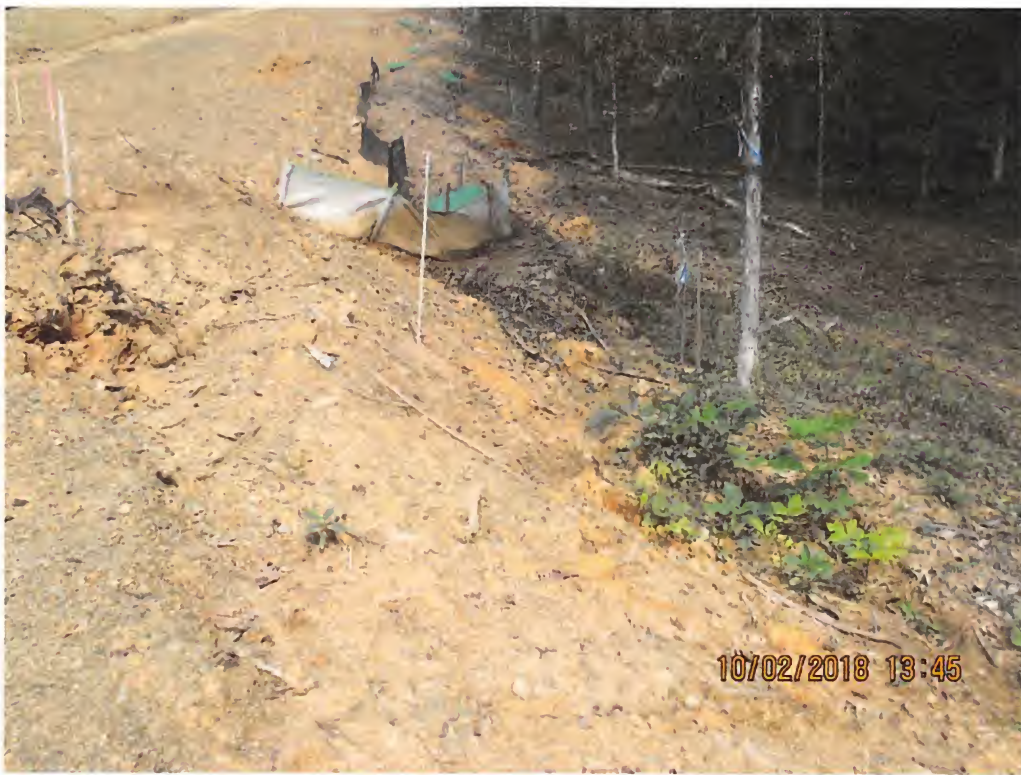
Off-site sediment deposits at Station #9717+52.
